HONEYWELL FALL PROTECTION FRANCE SAS  
35/37 rue de la Bidauderie  
18100 Vierzon, France  
www.honeywell.com

**Date:** January 31<sup>st</sup>, 2025

## **Safety notice - Falcon+ SRL models equipped with a cable and a swivel**

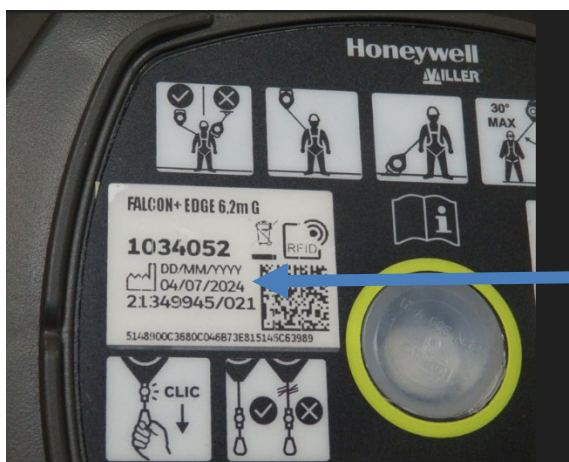
**Step 1: Identify the manufacturing date (DD/MM/YYYY): it is located on the label placed on the top of the plastic cover of the SRL**

**Manufacturing date**

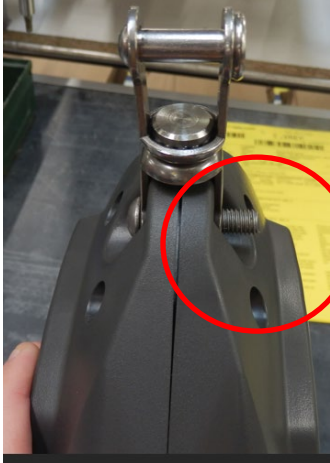
We have been informed of a non-conformity on Falcon+ SRL units: the tightening nut was missing at the swivel (see picture 1 below).

**DO NOT USE**  
(the nut is missing)

**If you discover any units missing the nut as indicated in Picture 1 above, immediately stop use, quarantine the product, and contact [techniserv.hsp@honeywell.com](mailto:techniserv.hsp@honeywell.com)**

Honeywell Customer Service will contact you and we will send you an official RMA form to return the product for examination by:

The service center will repair, check and inspect and send you back the serviced product.

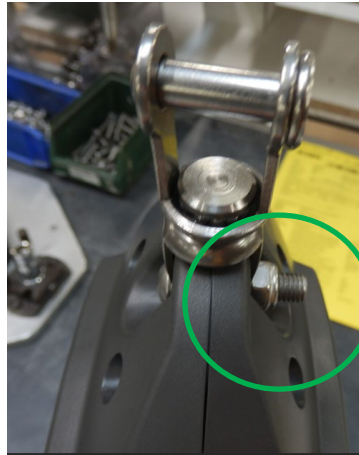
Picture 2

**OK TO USE**  
(the nut is on the swivel)
